Intel[®] Pentium[®] II Xeon[™] Processor Specification Update

Release Date: November 2001

Order Number: 243776-031

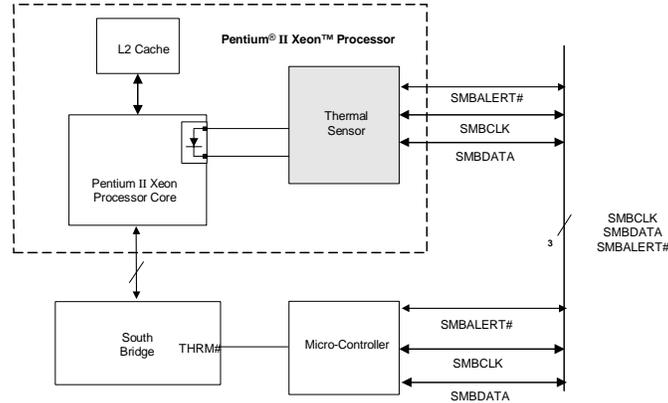
Figure 1. An Example of Microcontroller Driven Thermal Management

D30. Thermal Sensor May Assert SMBALERT# Incorrectly

Problem: The Pentium II Xeon processor has a thermal sensor that monitors the processor core's temperature. The thermal sensor asserts SMBALERT# if the processor temperature exceeds the temperature limits set in the Alarm Threshold Registers (T_{HIGH} , T_{LOW}). It also sets the corresponding Status Register bits to identify the cause of the interrupt. Figure 1 gives one example of the how the SMBALERT# signal could be used in a system.

Under the conditions described below, the thermal sensor incorrectly generates the SMBALERT# interrupt. *All* of the following conditions must be met to trigger a false interrupt:

Workaround: Three different (mutually exclusive) workarounds are possible:

1. Before servicing an interrupt from the thermal sensor, read and compare the processor thermal reading with the threshold limits (T_{HIGH} or T_{LOW}). Figures 2 and 3 provide basic flowcharts for the implementation of this workaround in an interrupt driven system.
2. If the firmware implemented polls the Status Register only, then before taking any action, re-read the temperature register and do a comparison with the alarm threshold limits (T_{HIGH} or T_{LOW}) to determine if the value is actually still within the temperature window.
3. Use a temperature polling scheme to monitor the processor temperature
