Intel[®] Pentium[®] III Xeon[™] Processor Specification Update

Release Date: November 2001

Order Number: 244460-031

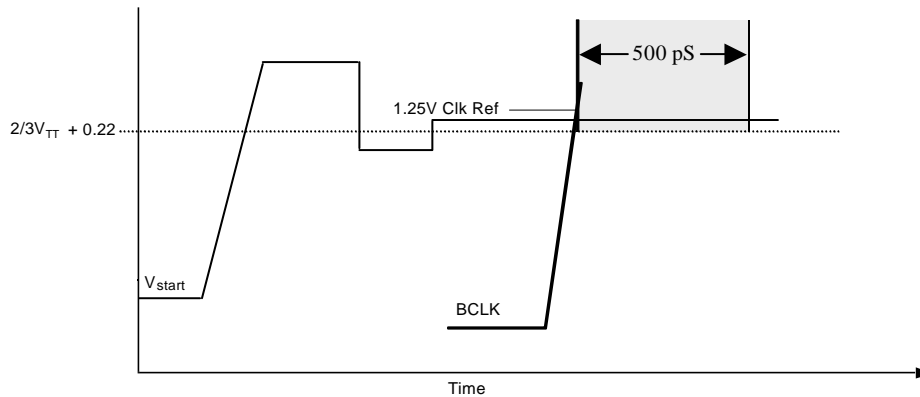
The published AGTL+ AC specification for $V_{IH(MIN)}$ is $(2/3 \cdot V_{TT}) + 0.1$ Volts.

Intel has characterized the new AGTL+ AC specification for $V_{IH(MIN)}$ on the processor's RS0# signal to be: $(2/3 \cdot V_{TT}) + 0.22$ Volts within 500 picoseconds following the rising edge of BCLK crossing the 1.25-Volt threshold. See below.

Implication: The deviation from the published specification results in decreased noise margin on the RS0# processor input. This decreased noise margin has been observed to be particularly detrimental in system environments where the RS0# processor input is being driven by an I/O buffer with a pull-up device (such as a p-channel transistor) that is switched off mid-cycle. Systems that employ I/O buffers that keep the pull-up device on for the entire cycle are significantly less affected by this erratum. The reduction in noise margin may lead to the generation of BINIT# (when enabled) resulting in a system reset, otherwise this condition may lead to a system "hang" condition.

Workaround: If a system design cannot meet the specification deviation, the following areas should be carefully examined to assure that additional margin exists in order to compensate for any deficit observed with respect to the newly characterized $V_{IH(MIN)}$ specification:

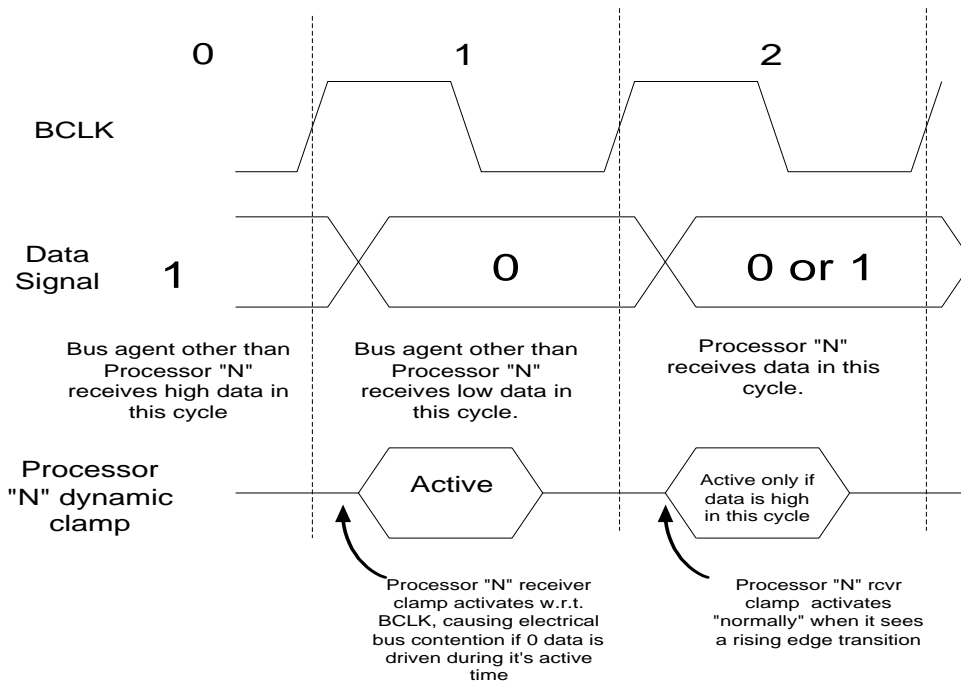
Problem: Falling edge ledge push-out and undershoot may be seen on AGTL+ data and data bus ECC signals. The AGTL+ receiver's dynamic clamp circuit activates (i.e. clamps the signal to an electrically high level) in certain cycles when data is driven to an electrically low level by another agent.

Implication: This erratum only occurs on a processor that does not receive data in that particular cycle. More specifically, this erratum only occurs when a specific processor does not receive data in the current BCLK period, but receives data in the very next period. Therefore, the processor inducing this falling edge noise (on data and data bus ECC signals) will not actually read the data in that cycle. See below for an illustration of this erratum affecting a processor denoted Processor "N". The falling edge ledges and undershoots may affect the signal quality and/or timing at agents that receive data in that cycle. Therefore, the impact of this erratum is highly dependent on system bus design.

Workaround: Evaluate system bus signal quality and timing margin at the valid receiving agent as a result of this falling edge noise. Due to dependence upon system bus design, bus layout may be evaluated to determine the need for improvements in signal quality and timing margin at the valid receiving agent as a result of this receiver-induced falling edge noise.
