Elite X2 1013 G3 Repairability Assessment

Elite X2 1013 G3 repairability assessment.

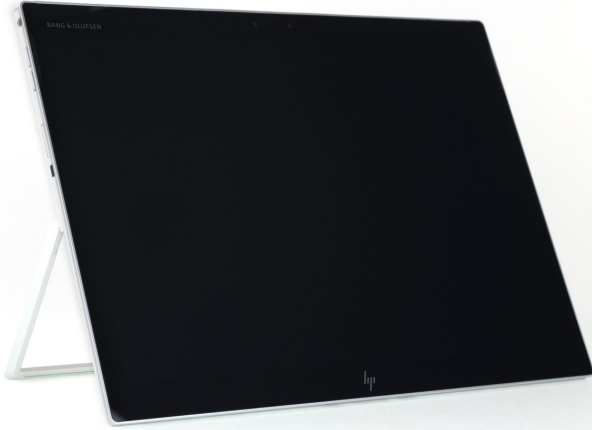
Step 1 — Elite X2 1013 G3 Repairability Assessment

- External reference.
- The tablet isn't ingress-proofed, so many gaps in the lower case (including ports, vents, speaker grilles etc.) may allow water damage or particle buildup.
- The hinge is also a point of mechanical failure.

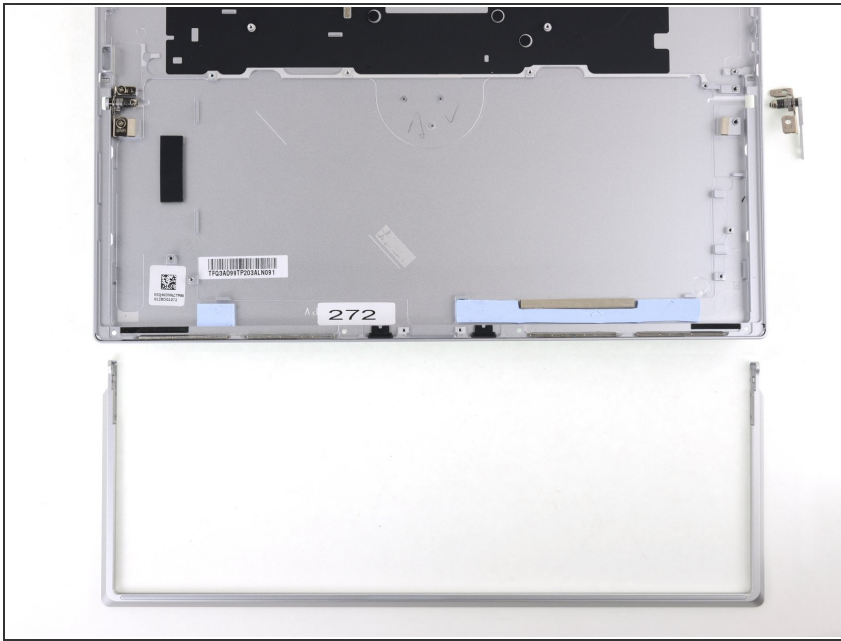
Step 8

- The hinges are replaceable once the rear case and the kickstand screws are removed. This can be done immediately upon opening the device.
- The hinges are a high-wear component and should be easily removable, and they are!

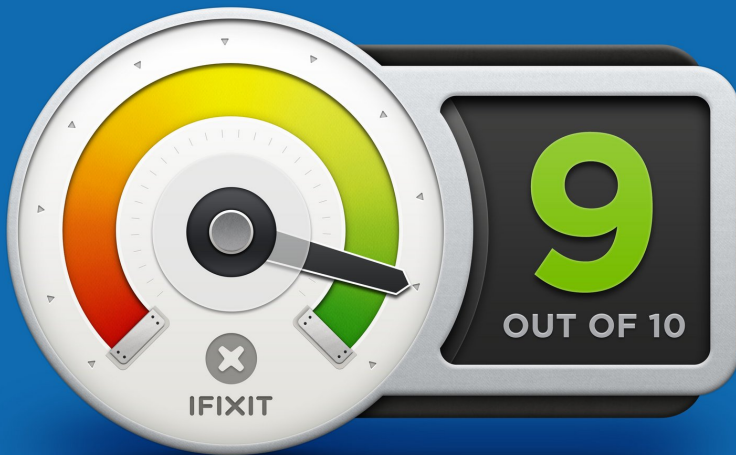
Step 10 — Final Thoughts

- HP Elite x2 1013 G3 Repairability Score: **9 out of 10** (10 is the easiest to repair):
 - All screws are standard Torx or Phillips.
 - Easy access to repair documentation and replacement parts by HP makes self-repair more feasible.
 - A modular and flat construction allows access to most components, but layering issues and excessive adhesive make the process less straightforward.
 - The flash storage can be easily upgraded or replaced, but the RAM is soldered to the motherboard—not really expected in a tablet, but still a bummer.
 - The display is fused to the front panel, simplifying repair but increasing the cost of an LCD or front glass replacement.
