# MacBook Pro 15" Touch Bar 2019 Teardown

Our search for the new 'material' in Apple's 15-inch MacBook Pro's butterfly keyboard unveiled two significant changes. Performed May 22, 2019.

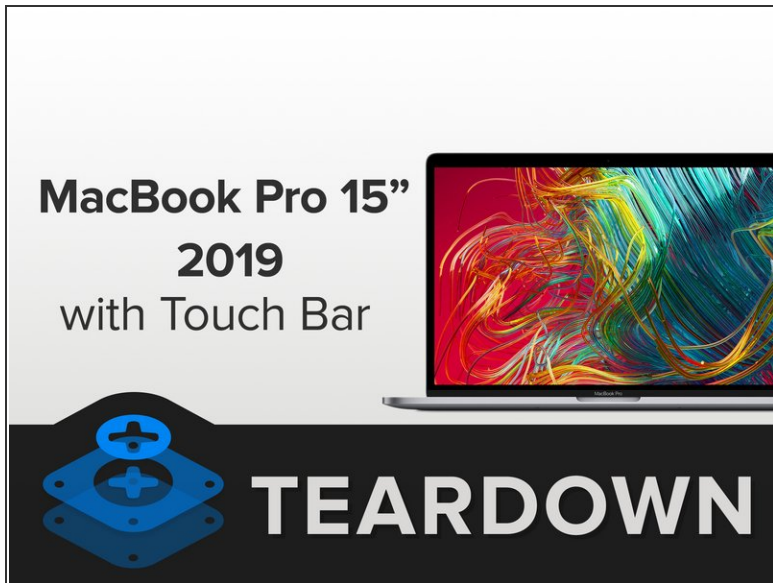
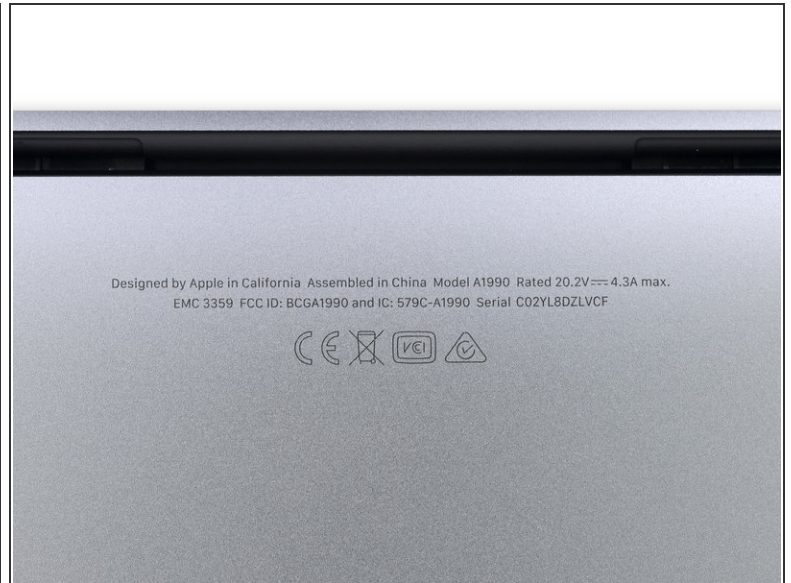
- On paper, this new 2019 MacBook Pro is only a spec bump—but just how bumpy is it? Let's recap:
  - 15.4" LED-backlit IPS Retina display with True Tone, 2880 x 1800 resolution (220 dpi), P3 wide color gamut
  - 2.6 GHz 6-core Intel Core i7 (Turbo Boost up to 4.5 GHz) paired with a Radeon Pro 555X
  - 16 GB of 2400 MHz DDR4 SDRAM
  - 256 GB PCIe-based SSD
  - 802.11ac Wi-Fi and Bluetooth 5.0
  - Four Thunderbolt 3 (USB-C) ports
- ⓘ Our teardown victim bears the familiar A1990 model number, but a new EMC number: **3359**.

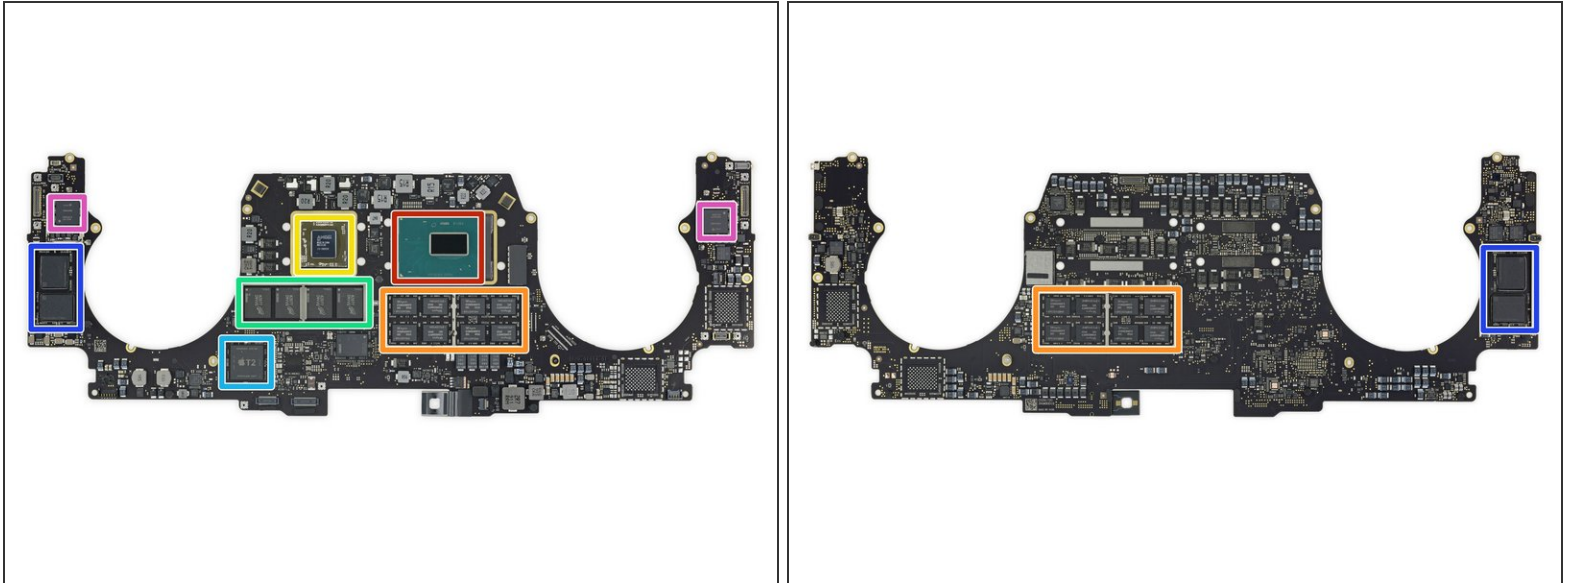
- With zero modular components, there's no chance of upgrading any of this hardware. Speak now or forever hold your chips:
  - 9th-generation Intel Core [i7-9750H](#) 6-core processor
  - 16x SK Hynix [H5AN8G8NAFR](#) 8 Gb DDR4 SDRAM (16 GB total)
  - AMD Radeon Pro 555X GPU
  - 4x Micron [MT51J256M32HF-70:B](#) 8 Gb GDDR5 RAM (4 GB total)
  - Apple T2 APL1027 339S00533 coprocessor, layered over 1 GB Micron D9VLN LPDDR4 memory
  - Toshiba TSB3226AW8815TWNA1 and TSB3226XZ2939TWNA1 flash storage (256 GB total)
  - Intel [JHL7540](#) Thunderbolt 3 controller

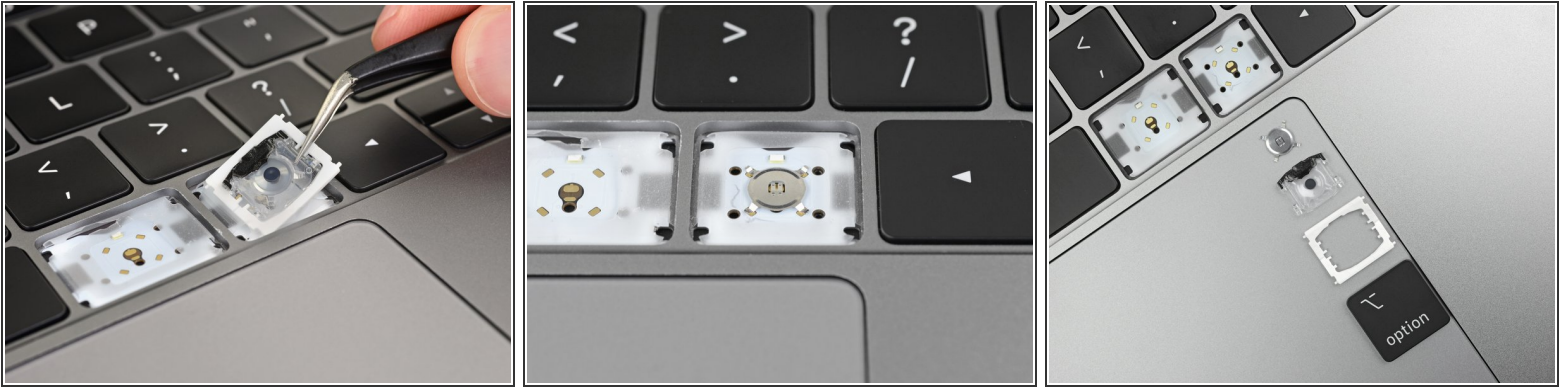
- Now that we have some context, let's go layer by layer through the key components of 2019's butterfly switch:
  - Topping it all off is the key cap. This has a handy label to tell users which key is broken.

- The hinged white bracket is the "butterfly" mechanism controlling the key's motion—stabilizing it so as to travel up and down without tilting or wobbling.

- Nesting within that bracket is a transparent cover that flexes with each key press, while keeping contaminants away from the dome switch underneath. The black dot at its center concentrates the force of your key press onto the switch.

- The main character of this assembly is the springy [metal dome switch](#). It deforms when the key is pressed, bridging the board's six contacts—and then bounces back when you release the key.

- Underneath the dome switch are [six metal pads](#). A keystroke registers whenever the top center pad is shorted to any of the other five pads.
  - To wrap it up, the silicone membrane covers the butterfly mechanism to keep debris from getting in and jamming it.

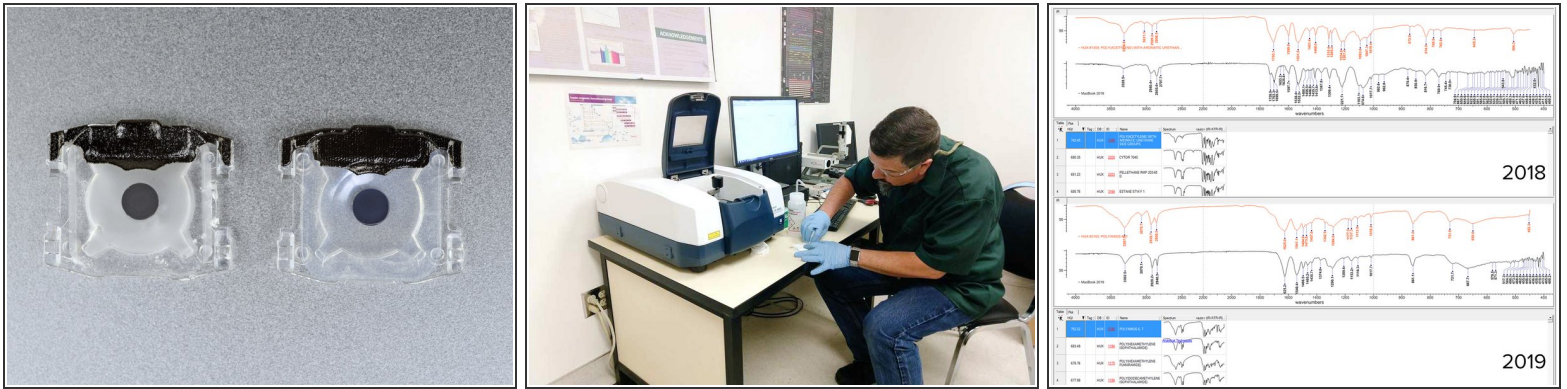
- So, what changed this year? First, the transparent switch cover material.
  - The cover in the 2018 model is semi-opaque, somewhat tacky, and feels like silicone. The new model is clearer and smooth to the touch.

- To confirm that the materials are indeed different, we analyzed them using Fourier Transform Infrared (FTIR) spectroscopy. Thanks to Eric Beaton and [Cal Poly's Materials Engineering department](#) for their equipment and expertise!

- ⓘ [FTIR analysis](#) works by shining infrared light at a material and measuring how much light is absorbed and at what wavelengths. This data acts like a fingerprint that can be used to identify the material.

- [The differing peaks and valleys](#) on the [FTIR spectra](#) for the two samples show us that they *are* different materials. But what are they?

- When comparing these FTIR spectra to that of known polymers, the closest match for the 2018 model is either poly(acetylene) with aromatic urethane side groups, or a type of TPU (which seems more likely). The 2019 model is a match for polyamide (commonly known as nylon).

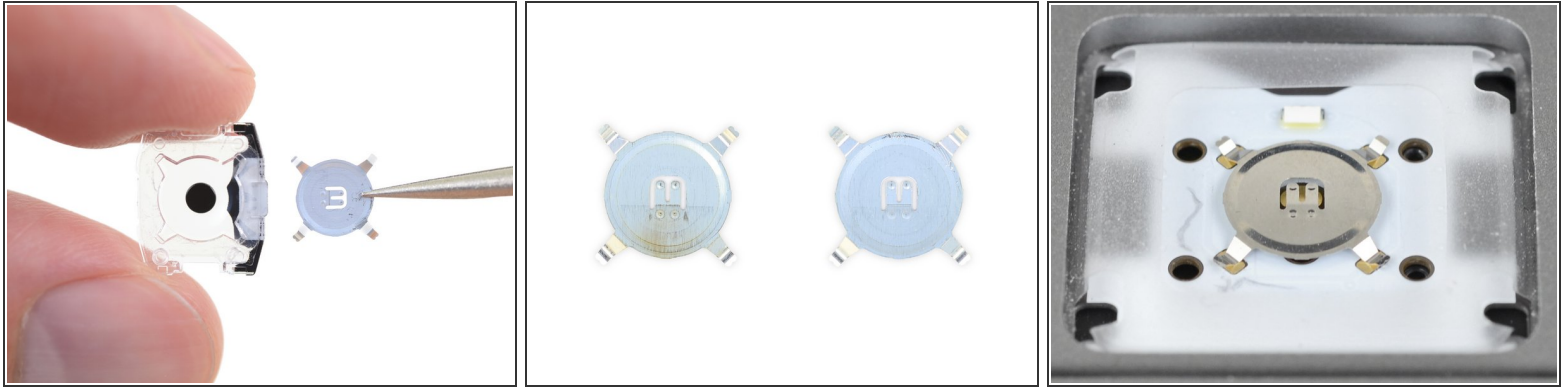
- What else changed? We think the metal dome switch may have. Let's look closer.
  - The dome is like a really tiny [jam lid](#) or [Snapple cap](#)—you press down and it springs back up.

- If anything changes about the dome—if it's cracked or deformed—the key may behave erratically. Likewise, if the prongs break or bend, the key stops working.

- ⓘ There are myriad possible reasons for this switch to crack or wear out—manufacturing defects, plain old fatigue, prolonged heat, moisture, outgassing from other components, and corrosion are all common culprits.

- 🔍 These switches are also magnetized from the factory. Best guess as to their composition: ferritic stainless steel, with a thin polymer coating on the bottom. The difference in surface finish from the 2018 version (left) to the 2019 (right) indicates Apple may be using a revised heat treatment, or alloy, or possibly both.
