# REMEDIATION OF THE MARWELL TAR PIT

USING ENHANCED THERMAL CONDUCTION FOR THE REMEDIATION OF EXTREME HYDROCARBON IMPACTS IN WHITEHORSE, YUKON TERRITORY

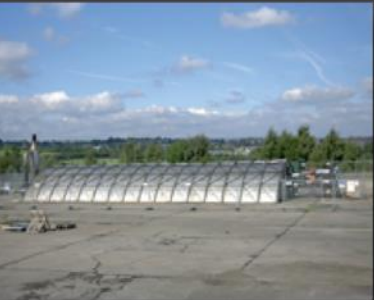
SIDE VIEW OF BURNERS ATTACHED TO CELL

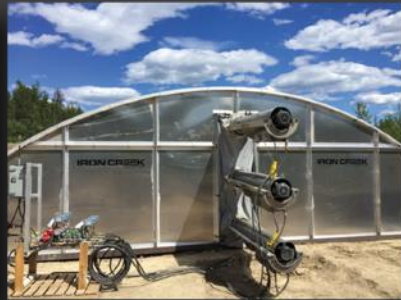
FRONT VIEW OF ASSEMBLED SOIL CELL

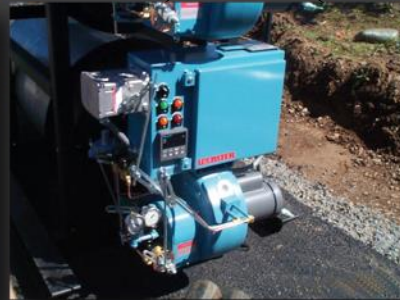
MULTI-FUEL BURNERS

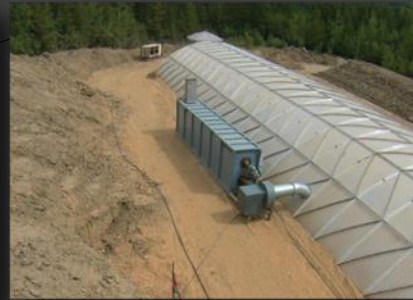
THERMAL OXIDIZER

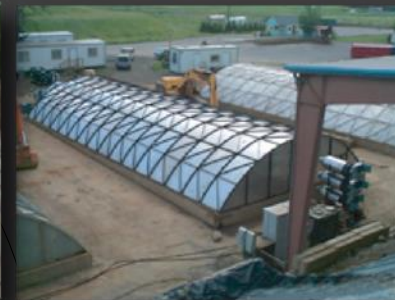
MULTIPLE CELLS RUNNING

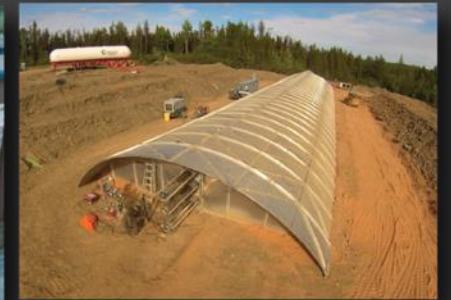
800 CUBIC METER CELL
