Dealer Service Instructions for:

## **Safety Recall W70 / NHTSA 20V- 622 Drivers Side View Mirror**

**2020 (DS) Ram 1500 Pickup  
(DJ) Ram 2500 Pickup**

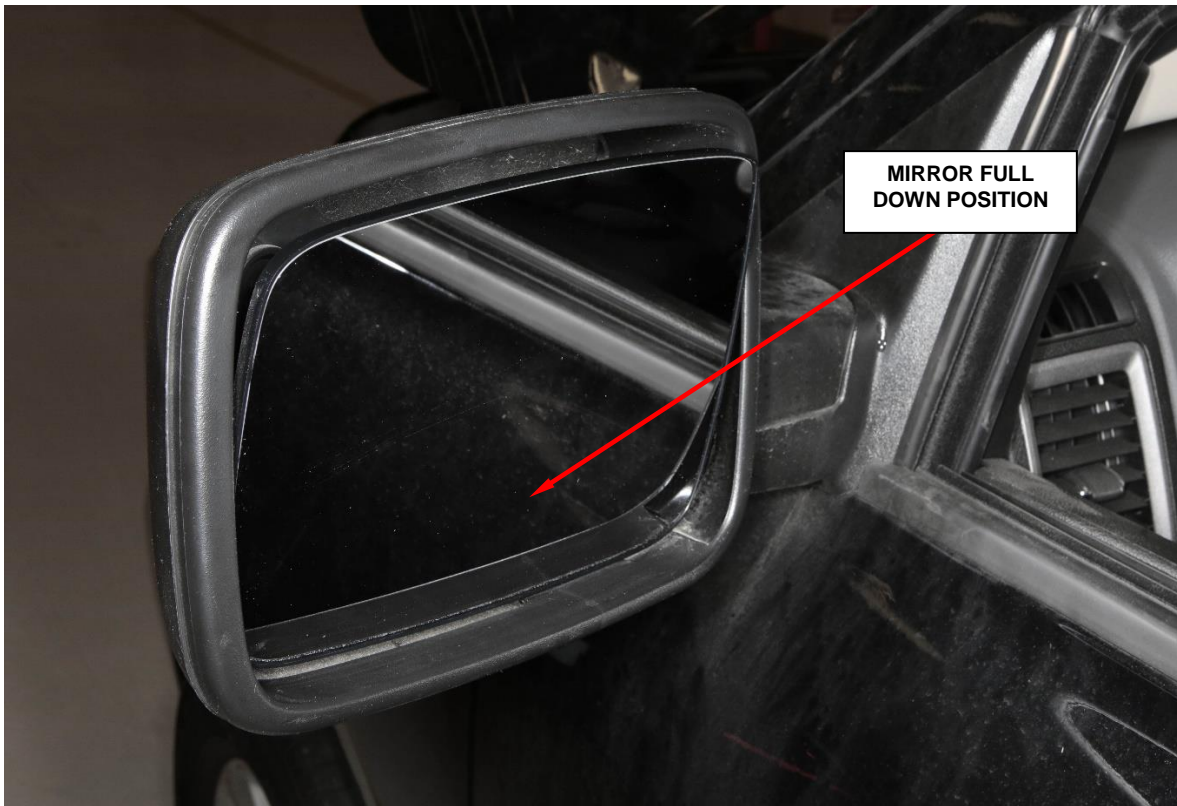
**Figure 1 – Drivers Side View Mirror**

1. Move the mirror into the full down position (Figure 1).

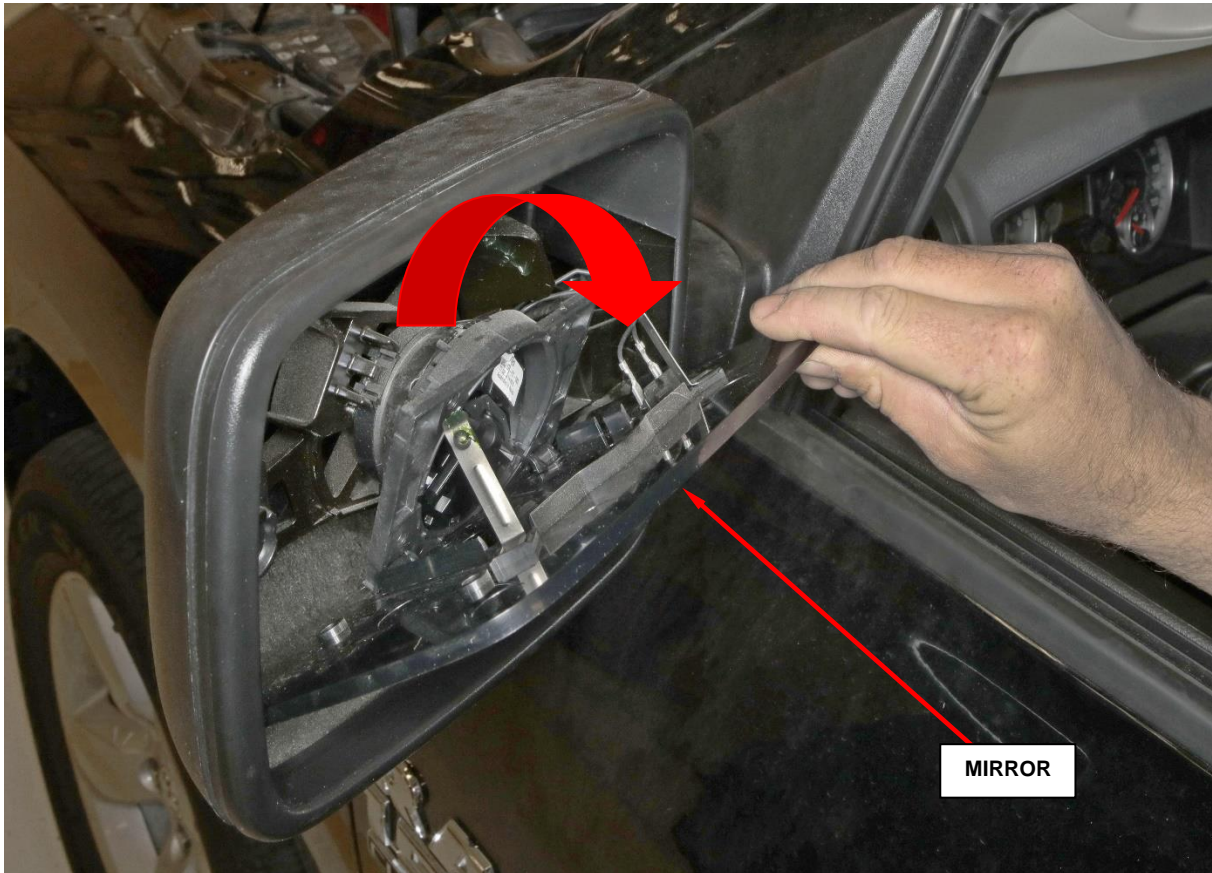
**Figure 3 – Mirror Glass**

4. Firmly and carefully grasp the mirror at the top and pull out to separate the upper mounting clips (Figure 3).
