Intel Atom[®] x6000E Series, and Intel[®] Pentium[®] and Celeron[®] N and J Series Processors for Internet of Things (IoT) Applications

Specification Update - Public

Revision 1.9

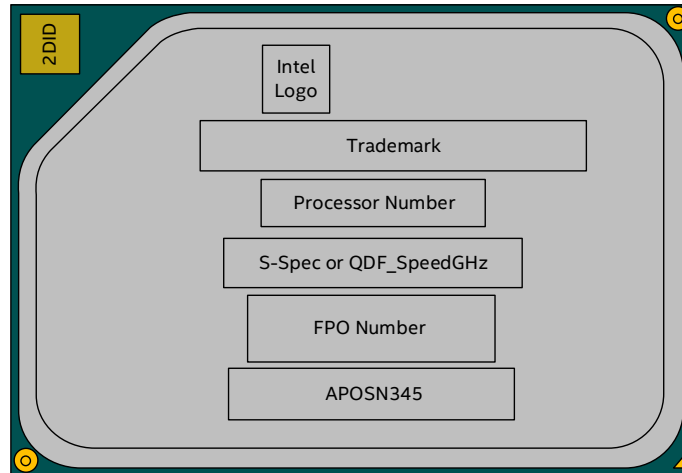
Figure 1. Processor Markings

The IHS (Integrated Heat Spreader) and bare die package processors are identified by the following component markings.
