HUAWEI SUN2000-100KTL-M1 Inverter

Low Insulation Resistance Fault

Indication Guide

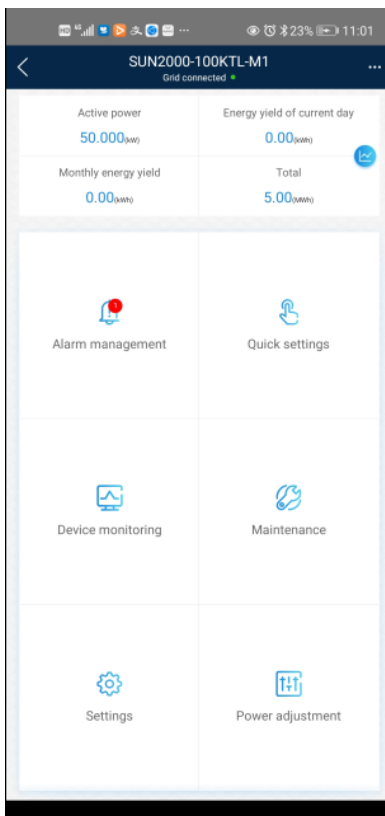
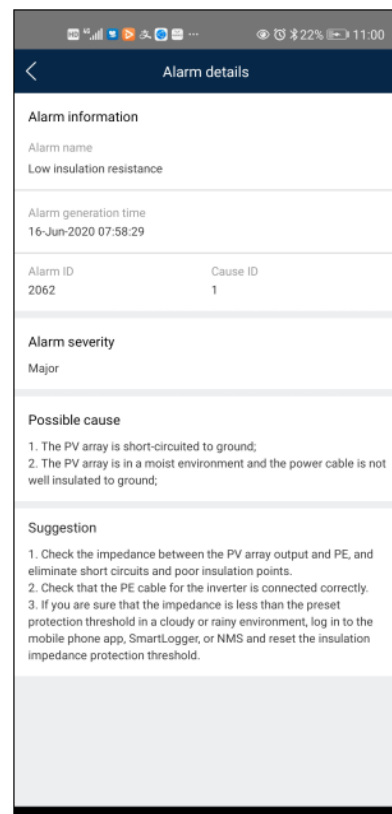
- When connecting FusionSolar App to inverter via external WLAN adaptor, low insulation resistance alarm or fault can be indicated via following interface by:

Click 'Alarm Management'

Select "Low Insulation Resistance" alarm
