## HUAWEI SUN2000-100KTL-M1 Inverter Low Insulation Resistance Fault Indication Guide

HUAWEI single phase residential inverter SUN2000-100KTL-M1 inverter has followed the requirement of AS 4777.2:2015 to detect earth fault via check the insulation resistance value. This inverter complies with IEC 62109-2 clause 13.9 for earth fault alarm monitoring. If an Earth Fault Alarm occurs, LED 1 and LED 2 will go red and fault code will occur in the app.

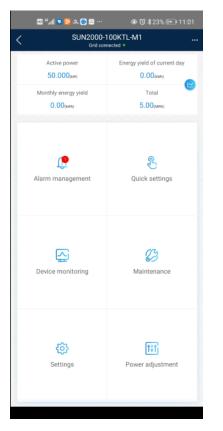
## Click 'Alarm Management'

Select "Low Insulation Resistance" alarm

11:00 @ ♂ ¥22% 匝 11:00
Alarm details
Alarm information
Alarm name Low insulation resistance
Alarm generation time 16-Jun-2020 07:58:29
Alarm ID Cause ID 2062 1
Alarm severity Major
Possible cause 1. The PV array is short-circuited to ground; 2. The PV array is in a moist environment and the power cable is not well insulated to ground;
Suggestion 1. Check the impedance between the PV array output and PE, and eliminate short circuits and poor insulation points. 2. Check that the PE cable for the inverter is connected correctly. 3. If you are sure that the impedance is less than the preset protection threshold in a cloudy or rainy environment, log in to the mobile phone app. SmartLogger, or NMS and reset the insulation impedance protection threshold.

• When connecting FusionSolar App to inverter via external WLAN adaptor, low insulation resistance alarm or fault can be indicated via following interface by:
