**47 CFR PART 15 SUBPART B TEST REPORT**  
**for**  
**Notebook Computer**  
**Model No.: RB14**

Applicant: **MilDef Crete Inc.**  
Address: **7F, No. 250, Sec.3, Pei Shen Rd., Shen Keng District,  
New Taipei City, Taiwan R.O.C.**

**Worldwide Testing Services (Taiwan) Co., Ltd.**

**Report No.: W6M22005-19938-P-15B**

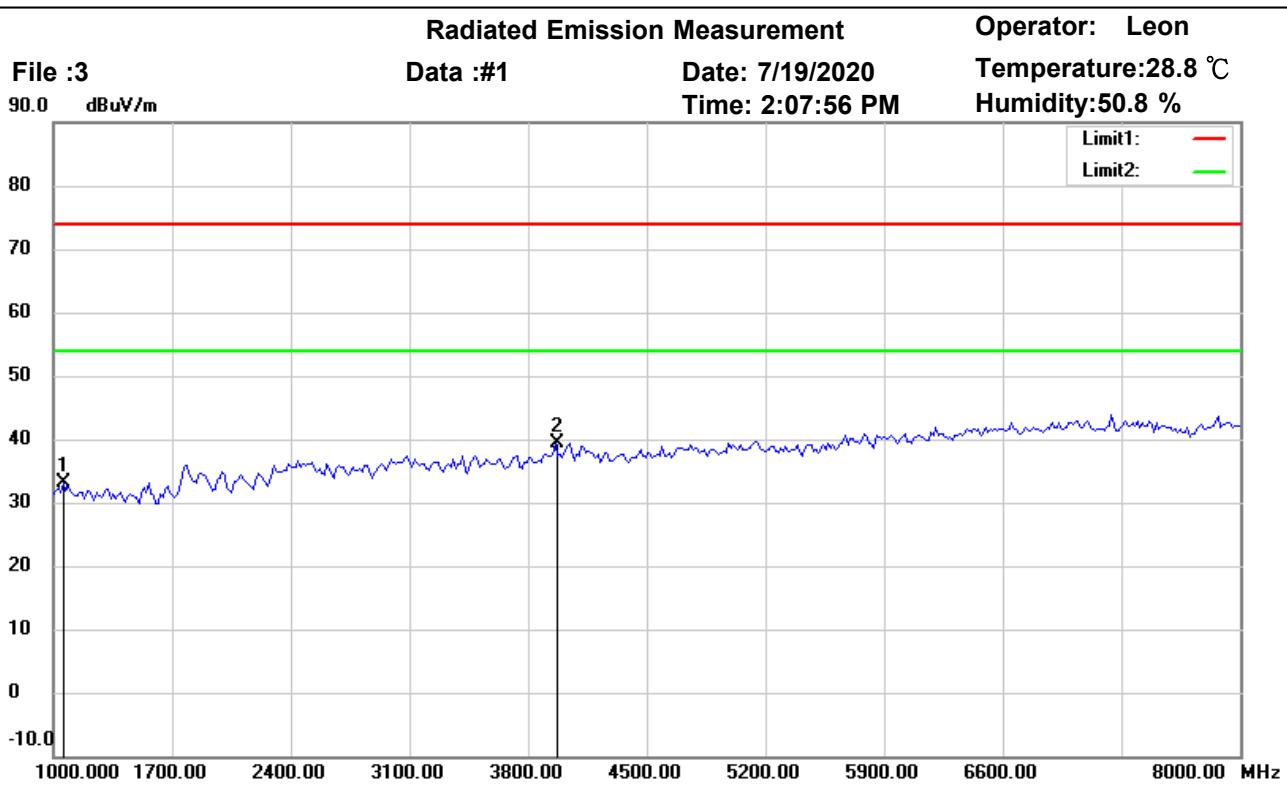
**Site :** Chamber**Condition :** FCC\_part 15 RE-Class B\_Above 1GHz\_PK**Polarization:** *Horizontal***EUT :** W6M22005-19938**Power :** 120 V.a.c.**M/N:****Distance:** 3m**Test Mode :** RX 802.11g CH1**Note :**

Mk.	Frequency (MHz)	Reading (dBuV)	Detector	Corr. factor (dB/m)	Result (dBuV/m)	Limit (dBuV/m)	Ant.Pos (cm)	Tab.Pos (deg.)	Margin (dB)	Comment
	1056.112	42.12	peak	-9.05	33.07	74.00	150	75	-40.93	
*	3959.920	41.38	peak	-1.90	39.48	74.00	150	169	-34.52
